Town of Arlington

FINAL REPORT

ADA Self-Evaluation (as basis for Transition Plan)

Prepared by
Institute for Human Centered Design
December 15, 2014

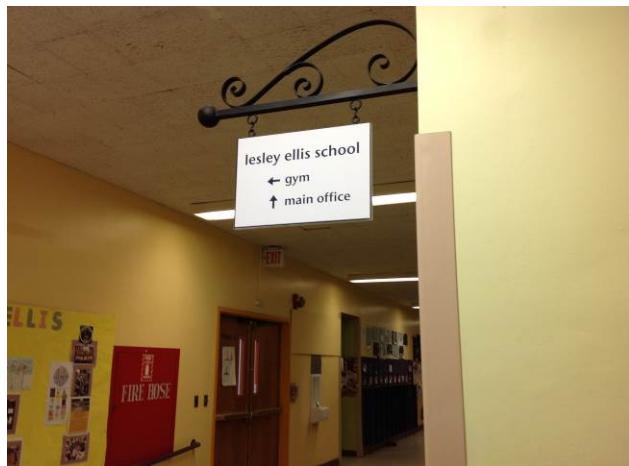
Photo 19

Within Gibbs Center, directional signage to Gibbs Gym is insufficient and poorly located. On level 1, no directory signs are offered at either entrance. Further, the only indication about the location of Gibbs Gym can be found on the control panel inside the elevator. On level 2, the only directional sign to Gibbs Gym is found above the doors to the main office of Lesley Ellis School. (Photo 19)

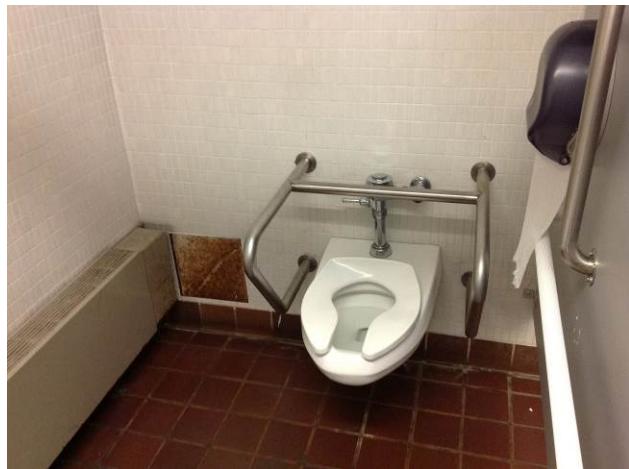
Photo 20

One set of multi-user toilet rooms (one for each gender) is provided near the elevator on level 1. Although these toilet rooms may have been code-compliant at the time of their installation, they do not meet the minimum requirements of either 1990 ADA Standards or the current accessibility laws and regulations. Toilet rooms are inaccessible because faucets are non-compliant, plumbing underneath lavatories are not protected, mirrors are too high (49" above the floor), paper dispenser are too high (52" above the floor), accessible toilet stall have non-compliant grab bars, and no alarms are provided. (Photo 20)

- Replace the faucets of at least one lavatory with ADA-compliant fixtures;
- Protect the plumbing underneath of at least one of the lavatories in each toilet room;
- Lower at least one mirror above a lavatory so that its reflective surface is no higher than 40" above the floor;
- Lower paper dispensers so that their controls are no higher than 48" above the floor;
- Replace grab bars with ADA-compliant accessories inside the accessible toilet stalls;
- Install audible and visible fire alarms.

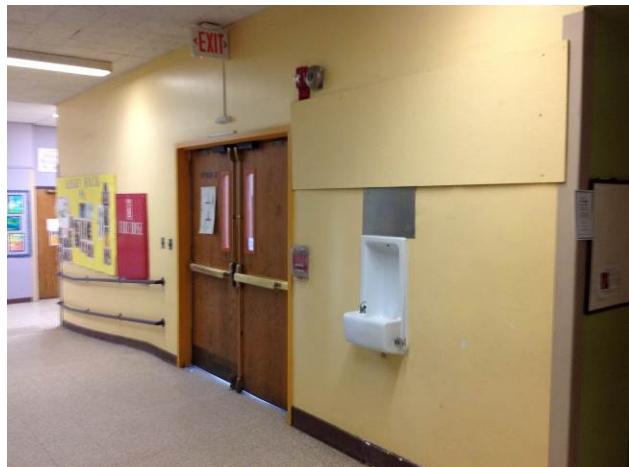
Photo 21

One wall-mounted drinking fountain is provided near Gibbs Gym on level 2. Such fixture is not ADA-compliant. (Photo 21)

Replace the existing fixture on level 2 with an ADA-compliant fixture. In the meantime, provide an adjacent water cooler with cups for

equivalent access at the inaccessible drinking fountain.

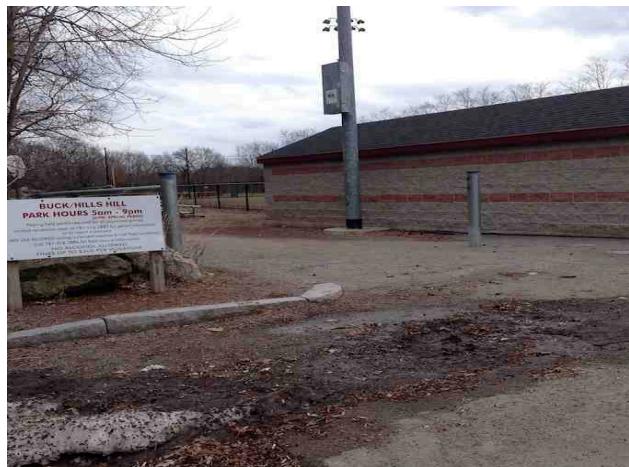
Photo 2

The point to entry that includes facility signage is shared with Buck Field. This entrance is uneven and needs maintenance. (Photo 2)

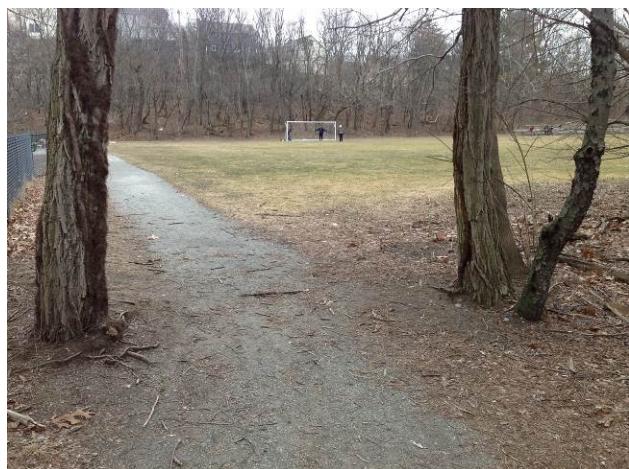
Photo 3

The point of entry from the Bikeway Shared-Use Trail is a well-graded stone dust pathway. (Photo 3)

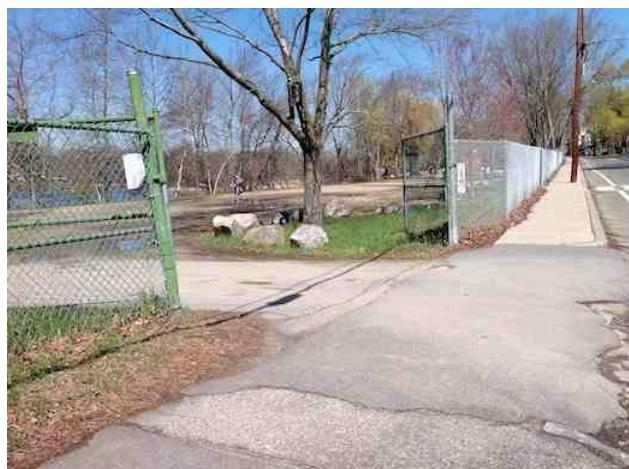
Photo 3

Sidewalk along Westmoreland perimeter fence needs maintenance. The pedestrian zone is not blended to level and smooth at parking lot entry point. Sidewalk has excessive cross slopes. (Photo 3)

Drake Road: Evaluate existing sidewalk panels from and replace panels with cross slopes exceeding 2.08%.

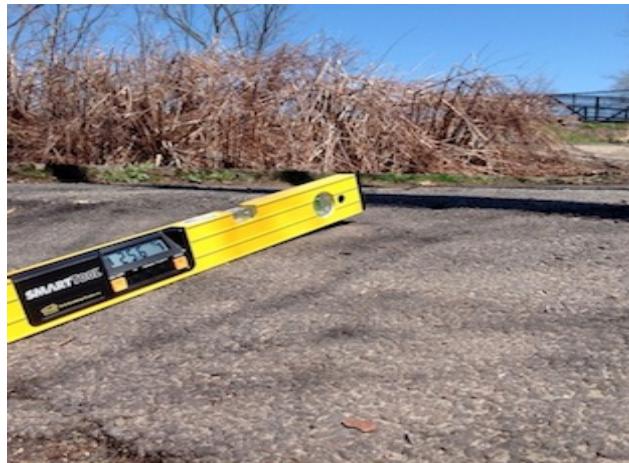
Photo 8

Secondary trails branching off the trail to Wildlife Garden and in the direction of Hurd Field are excessively steep and are not usable until they can be re-graded to minimal slopes with additional natural wall (or handrail) supports. (Photo 8)

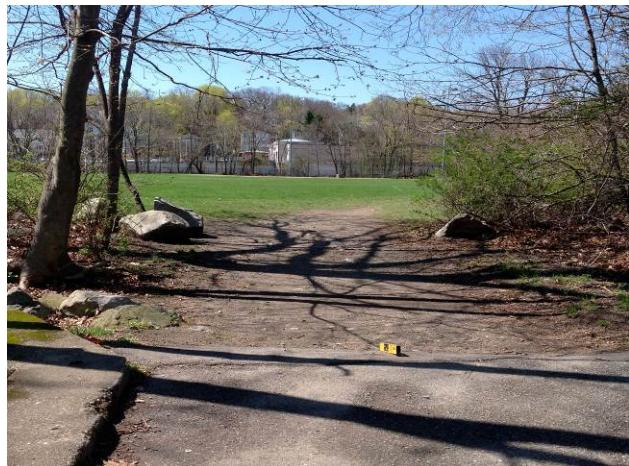
Photo 9

The informal trail between the back of Hurd Field and the Reservoir Trail at the spillway bridge is particularly hazardous and does not provide an accessible connection between the two sections of this multi-use facility. (Photo 9)

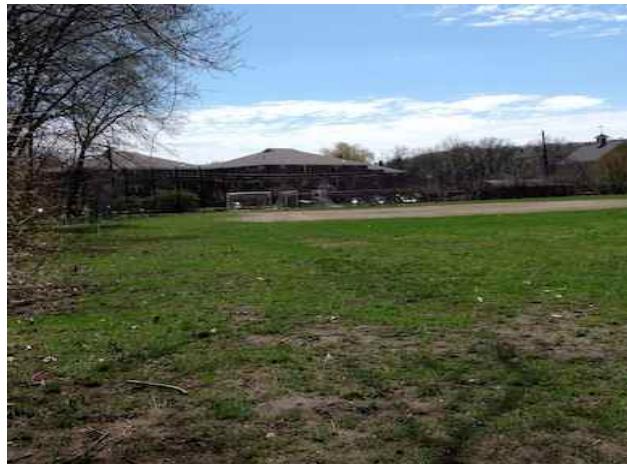
Photo 10

There are no accessible path connections between the paved parking lot and perimeter of field playing areas. There are no accessible paths and firm, smooth ground surfaces to and within the team meeting and seating locations. (Photo 10)

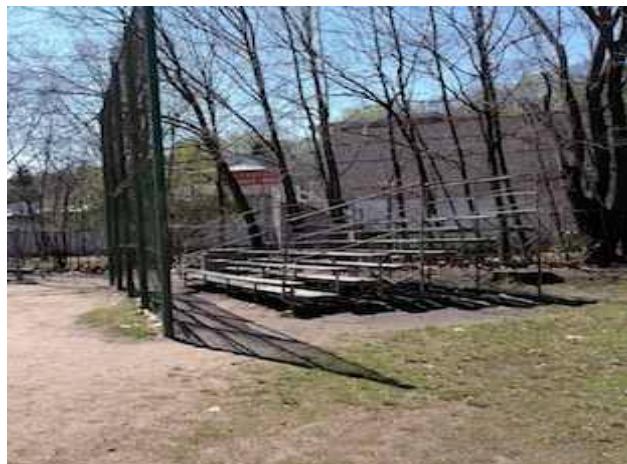
Photo 12

There are no accessible route connections to the spectator bleachers at the larger Hurd Field ball field at this time. These are not accessible bleachers and there is no clear, firm and level ground spaces provided for wheelchair spectator locations. (Photo 12)

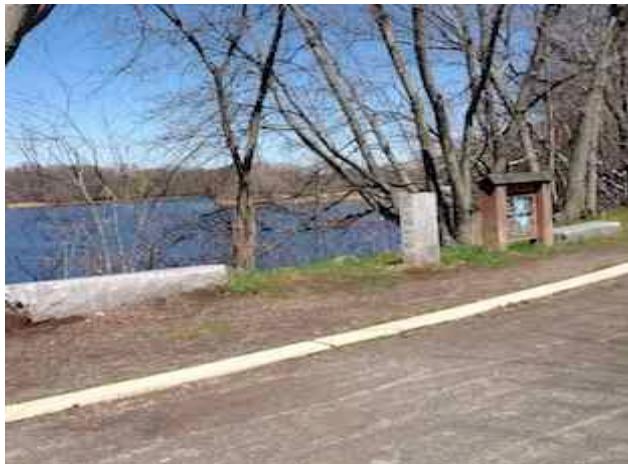
Photo 13

The sign explaining the EPA Porous Pavement project at the Drake parking lot; and the Map installation at the Lowell St. Trail entry point do not provide accessible clear ground approach and viewing conditions due to mounting heights (EPA sign) and distance from trail edging (Map). (Photo 13)

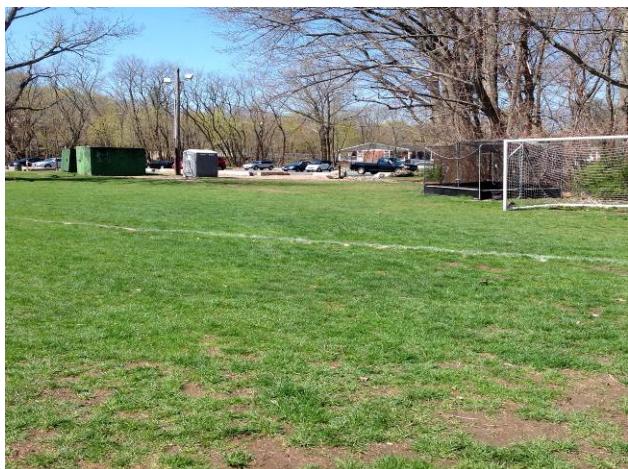
Photo 15

A portable toilet installed at the edge of Hurd Field is not adjoining an accessible path and does not provide an accessible level, firm ground surface for entry. (Photo 15)

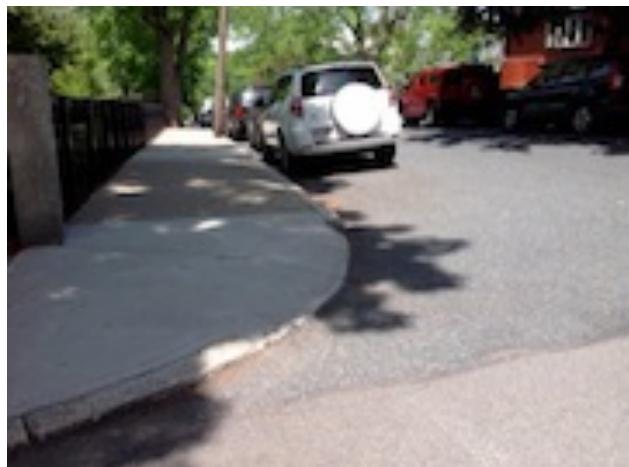
Photo 2

Curb ramps at intersection of Paul Revere Road and Davis Ave. are inadequately constructed, with excessive run slopes, no flared sides, and a non-gradual transition to street. (Photo 2)

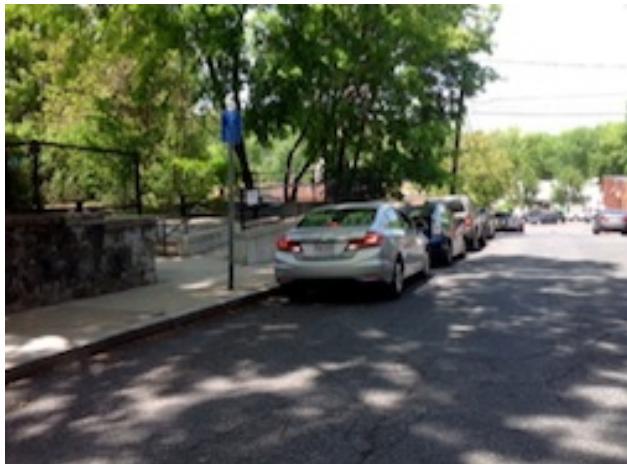
Photo 4

There is 1 designated accessible parallel parking space outside Park entry. There are some excessive cross slopes on sidewalk between parking space and Park entryway. There is no curb ramp along this mid-sidewalk location. (Photo 4)

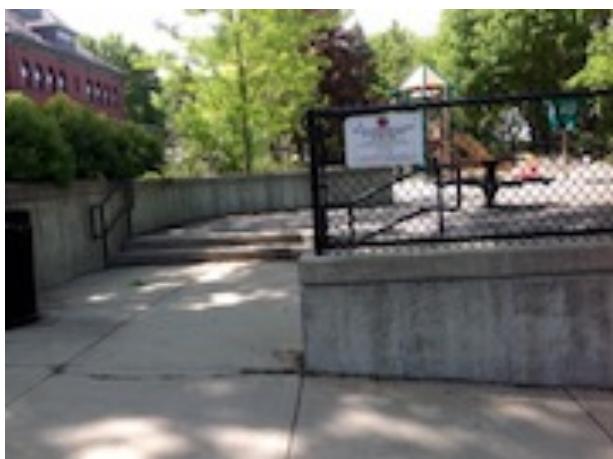
Photo 6

Entryway panels have some minor cross slope issues. (Photo 6)

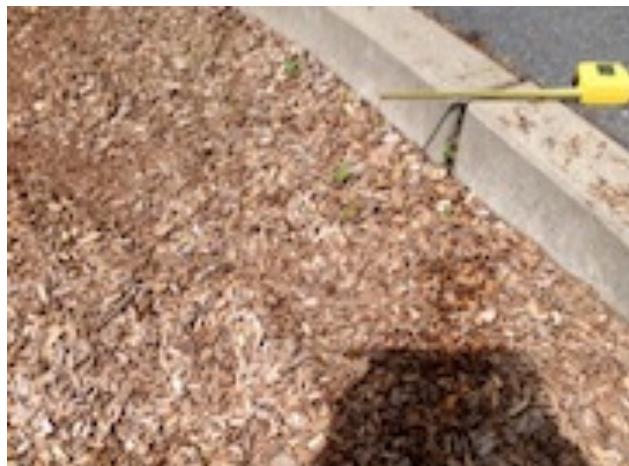
Photo 10

There is not yet an accessible, level connection between the ground surface of the recessed play areas and the adjacent cement walkways due to the high borders around the compacted loose fill surfaces. (Photo 10)

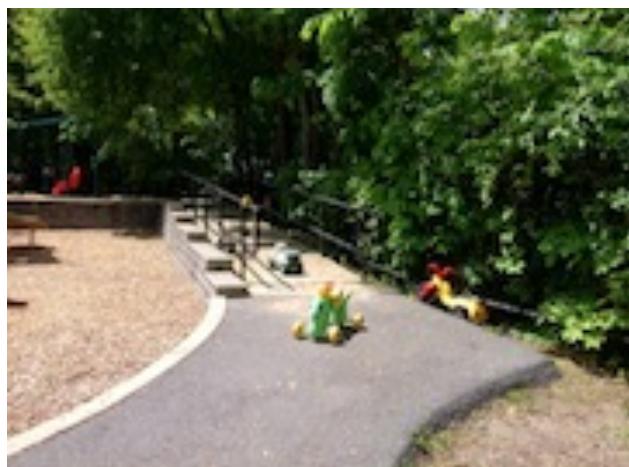
Photo 11

The lack of a level entry/exit into the recessed play areas on both levels prevents an accessible route connecting the bottom and top of the slides, despite the walkway ramp connection just out of level reach. (Photo 11)

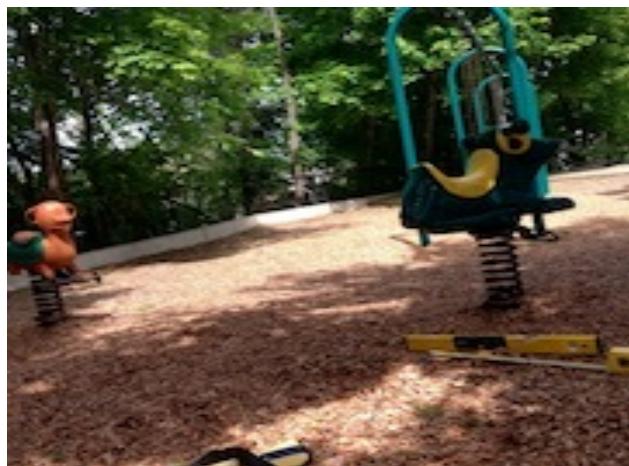
Photo 12

Although the loose fill ground surface materials may provide adequate impact attenuation conditions, these materials are not currently maintaining minimal slopes and the firmness needed for accessibility conditions. (Photo 12)

a. If loose fill ground surface materials are still used, a high-frequency maintenance policy needs to be implemented to ensure accessible routes in recessed play areas through all seasons.

b. If ground surface materials will be replaced: consider resurfacing all or portions of the recessed play areas with unitary surface materials that are resilient and also provide accessible levels and firmness.

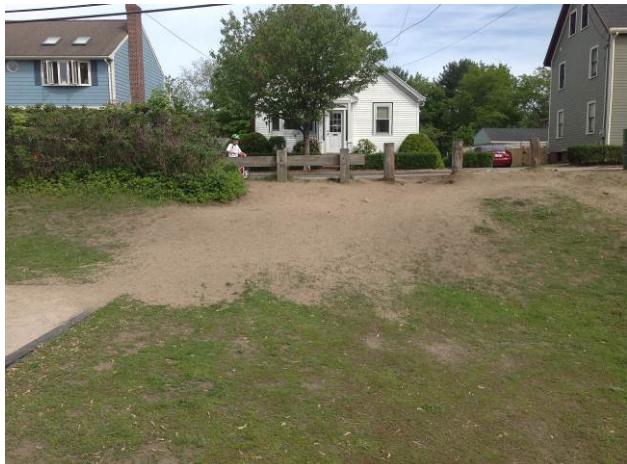
Photo 1

Due to the lack of another option, the walkway leading to the playground on North Union Street has been used by the public as a *de facto* point of entry to this facility. (Photo1)

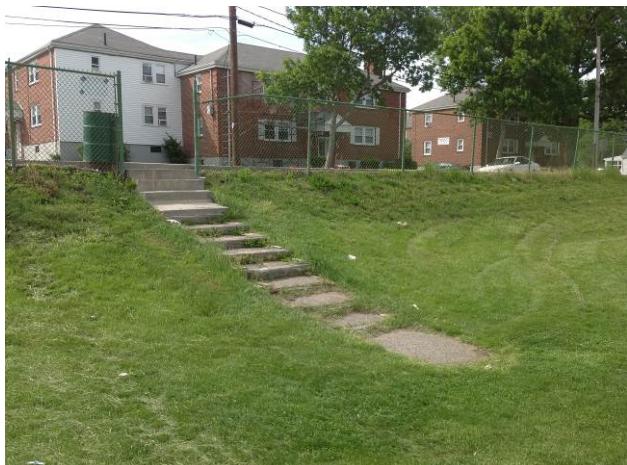
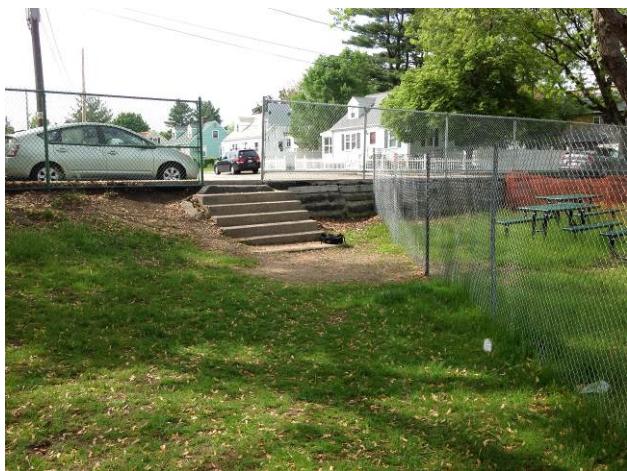
Additionally, neither of the stairways on North Union and Everett Street have compliant railings on both sides. (Photos 2 and 3)

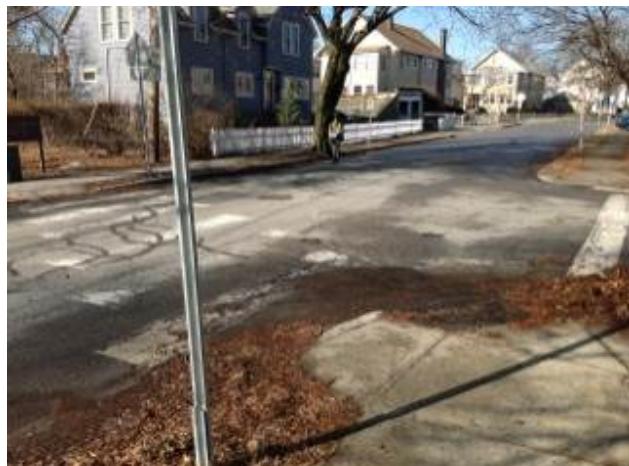
Photo 1

One highly visible crosswalk and three curb ramps are provided at the intersection of Magnolia Street and Herbert Road. Neither curb ramp is accessible because they have excessive running slopes (9 % to 12%). (Photo1)

Repair curb ramps at the intersection of Magnolia Street and Herbert Road (total of 3 curb ramps).

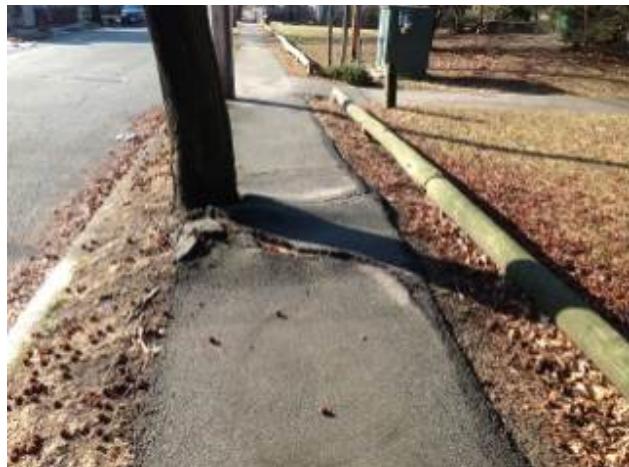
Photo 2

Although the sidewalks along Herbert Road and the Minuteman Commuter Bikeway are mostly accessible, the sidewalk along Thorndike Street is in poor condition. Not only are a few sections near trees extremely deteriorated but also the sidewalk has excessive cross slopes. (Photo 2)

Repair the sidewalk along Thorndike Street (about 300 feet).

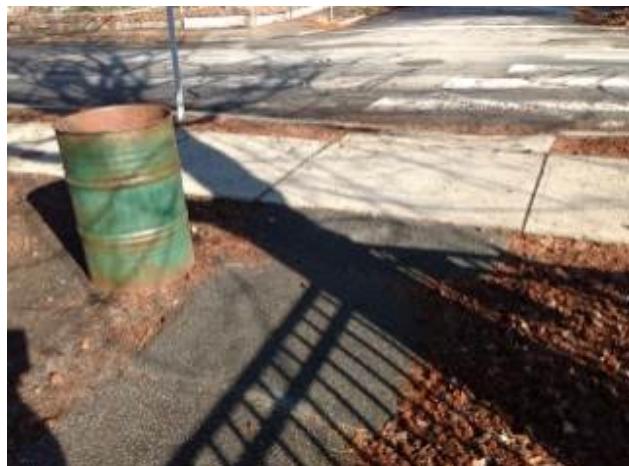
Photo 3

This facility has four at-grade points of entry: two on Herbert Road, one on Thorndike Street, and one along the Minuteman Commuter Bikeway. On Herbert Road and on Thorndike Street, the asphalt walkways at the edge of the sidewalk have excessive slopes (15.5% and 14%, respectively). (Photo 3)

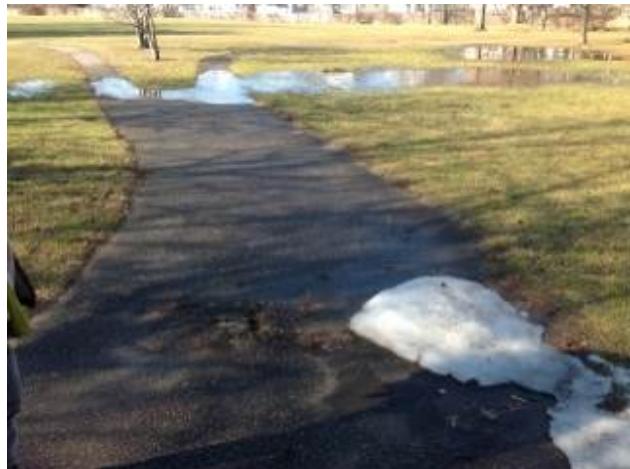
An asphalt walkway is provided between the points of entry and most features in the facility. However, the section of the asphalt walkway near the point of entry at Thorndike Street is in poor condition and obstructed by ground water pooling.

Additionally, between the points of entry at Thorndike Street and the Minuteman Commuter Bikeway, the asphalt walkway has sections that are too narrow (less than 36" of width) and is obstructed by deteriorated surface and tree canopies that protrude within the necessary vertical clearance needed along the pedestrian path. (Photos 4 and 5)

Between the points of entry at Thorndike Street and the Minuteman Commuter Bikeway, repair and widen the asphalt walkway to 48" of width (about 575 feet) and trim trees so that branches over the path are no lower than 80" above the ground.

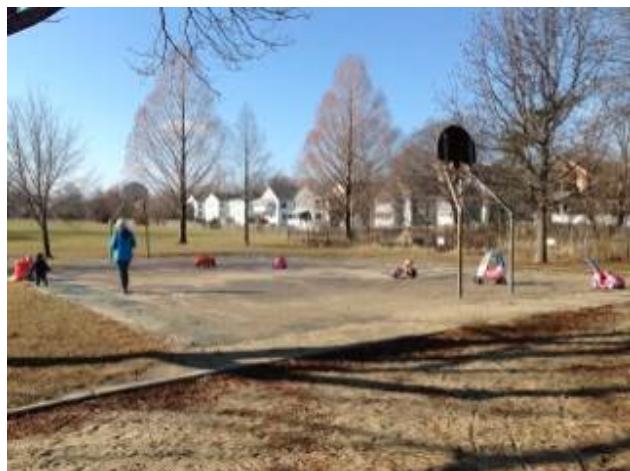
Photo 6

Although an asphalt walkway is provided between the points of entry and certain features in this facility, no accessible route is provided between the asphalt walkway and the basketball court. (Photo 6)

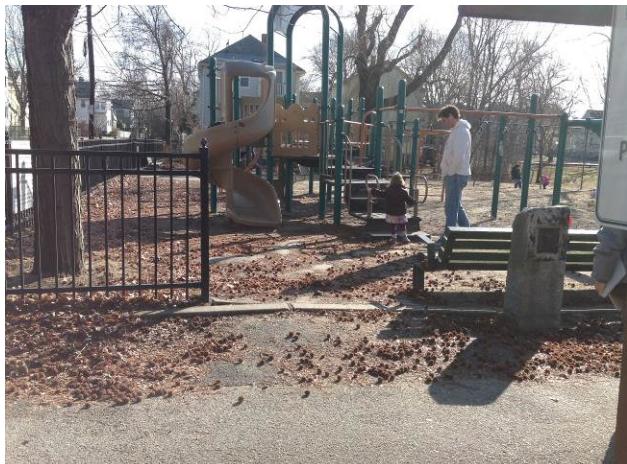
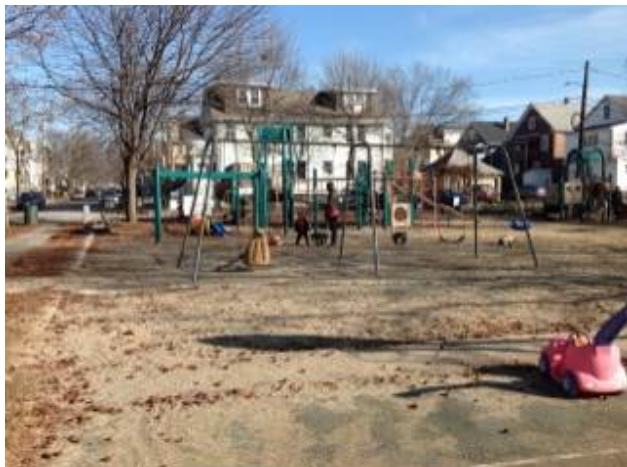
One large sandy area contains separate zones of play structures. Although an accessible route is provided to the small play structure on Herbert Road and the swingset adjacent to the asphalt walkway, no accessible route is provided to the rest of the playground.

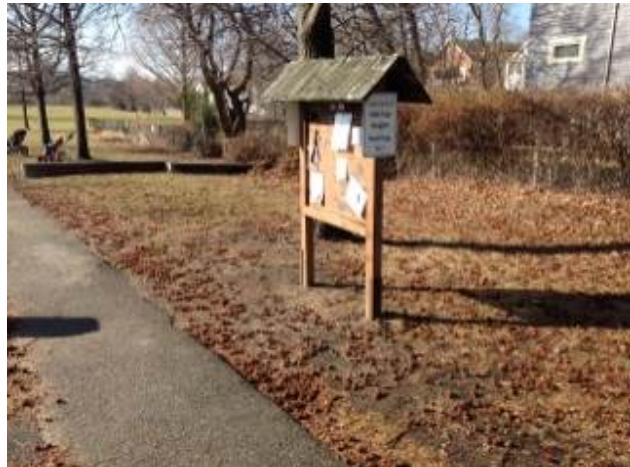
Photo 11

A bulletin board is provided near the point of entry at Herbert Road; however, a level, clear viewing area is not provided in front of the bulletin board and the adjacent paved circulation route does not yet include continuous accessible conditions. (Photo 11)

- 1 Bulletin Board:** Although not a requirement under the ADA, consider extending the asphalt walkway to the bulletin board.
- 1 Community Garden:** Completely re-configure the community garden so that accessible routes as well as planter beds at an accessible height and other features are provided within the garden.

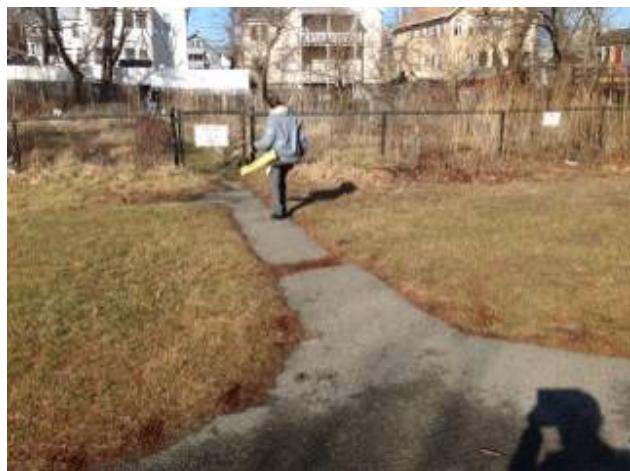
Photo 12

A gated community garden is provided near the point of entry at Herbert Road. Although the asphalt walkway connects this amenity to the rest of the facility, no accessible route or features, including an accessible gate, are offered within the garden. (Photo 12)

Completely re-configure the community garden so that accessible routes as well as planter beds at an accessible height and other features are provided within the garden.

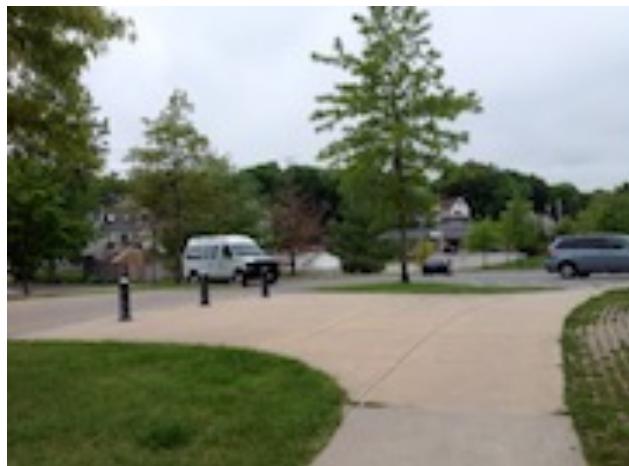
Photo 4

The first parking area has 48 spaces with two designated as accessible and sharing an access aisle. The walkway from these spaces has excessive cross slopes; and does not provide an accessible route to the points of entry leading to the skateboard park, between the park and the playground, or into the playground. Uneven surfaces, and excessive slopes impede the route from the designated parking spaces to the asphalt walkway into the playground.

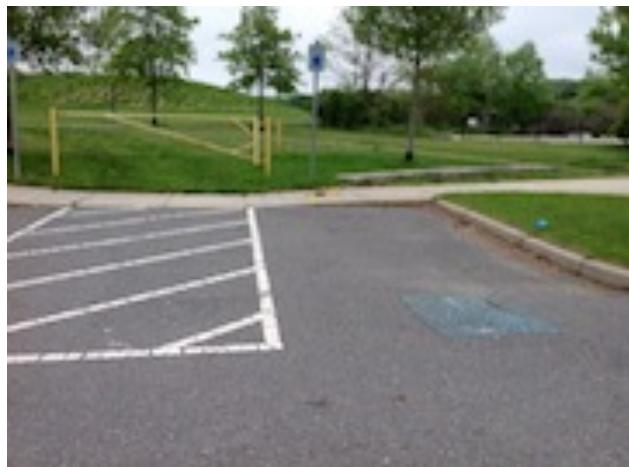
Photo 5

The second parking area has 27 parking spaces with two designated as accessible. These spaces share an access aisle, which leads to a walkway with excessive run slopes covered by hard tactile tile surfaces on both sides of the sidewalk adjacent to the access aisle. These sidewalk panels should not be treated as a curb ramp but rather, as a walkway. If the terrain cannot be regraded to maximum 5% slopes, then handrails should be added and this portion of the walkway treated as a ramp (not as a curb ramp).

The interior walkway leading to the sitting area between the two play areas is the only walkway that provides a continuous accessible route into a facility area; however, this walkway is not connected along an accessible route to the designated accessible parking spaces. (See Photo 5, previous page)

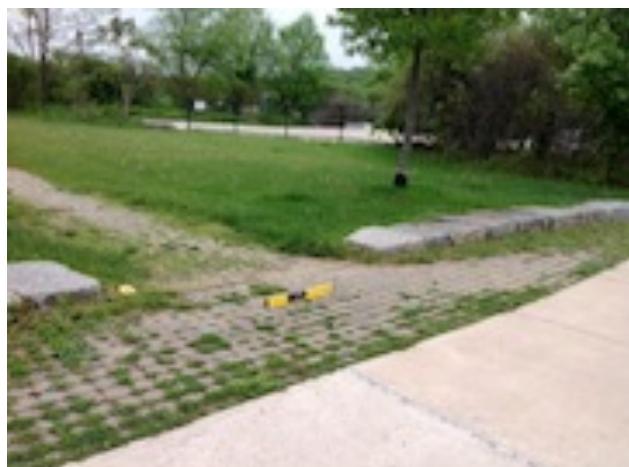
Photo 6

From the parking facility, there are four points of entry into different program areas leading into field walkway, picnic area, between skateboard park and the playground, and to sitting area within playground area. Only the walkway into the playground sitting area is accessible (Photo 6)

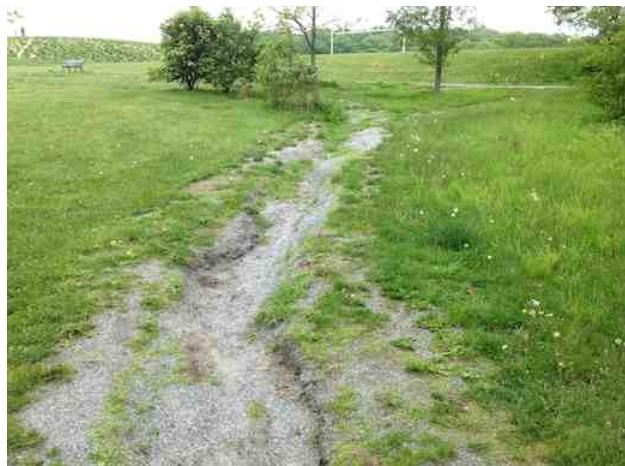
Photo 9

The circulation route around the fields and adjacent to Reed's Brook is uneven. Stone dust paths have eroded and dirt pathways do not hold accessible slopes and are not level. (Photo 9)

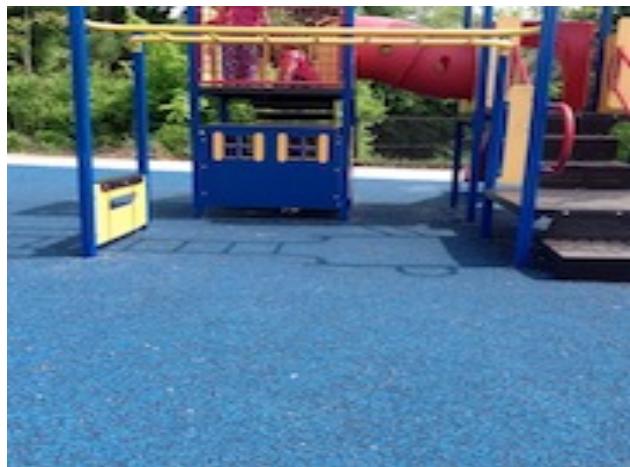
Photo 11

The smaller play area has a proportionate number of accessible ground elements to the number of elevated play elements that can only be reached by transfer steps. The swingset includes bucket seats. (Photo 11)

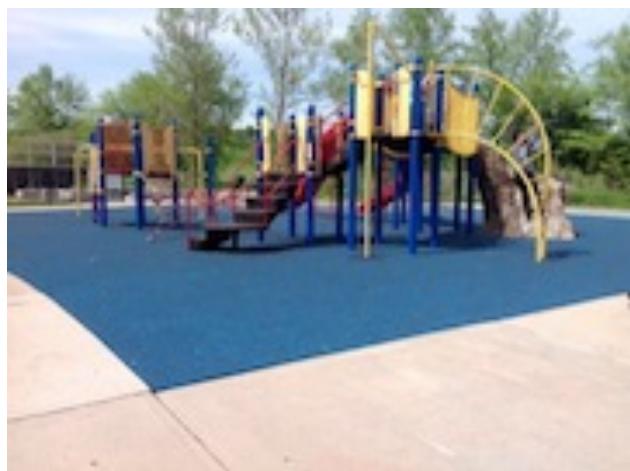
Photo 12

The large play area for older children has at least twenty play components total, and no elevated accessible route. The transfer system requires many steps to reach elevated play components. The trampoline is also accessed by steps or by climbing over the rim, which is a reach of over one foot. There are no accessible elevated routes to reach the mostly elevated play components. (Photo 12)

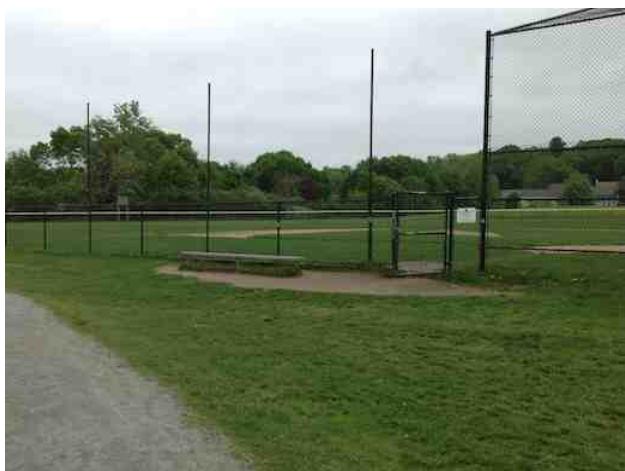
Photo 14

There is a large picnic area at the grassy open fields just beyond the playground and skateboard park areas. There are no accessible picnic tables with provision of table and knee clearance for individuals using wheeled mobility devices. Picnic area and tables are not currently connected by any accessible pathway to nearby facility walkways. (Photo 14)

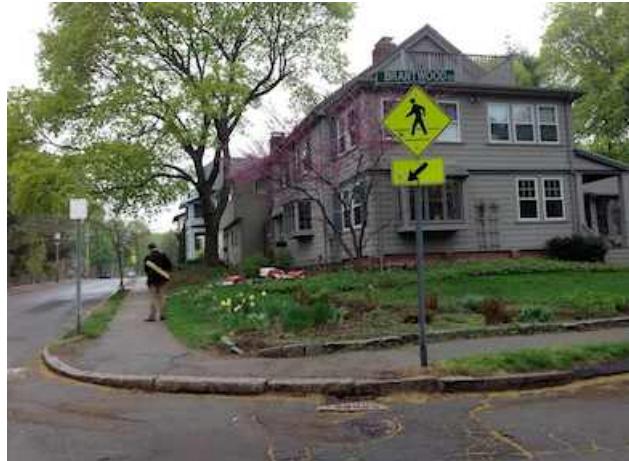
Photo 2

Curb ramps are missing at junction of Brantwood Rd & Jason St. (Photo 2)

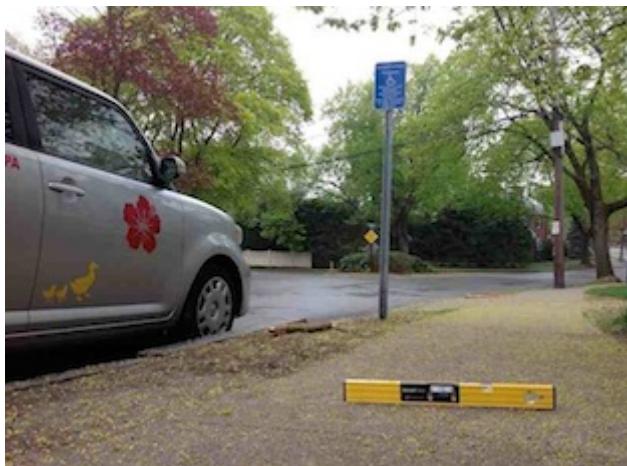
Photo 4

A designated accessible parking space is located close to facility entrance. The sidewalk and ramped driveway adjoining this space do not have accessible run or cross slopes. (Photo 4)

If roadway profile grade crowns at 5% or less, reconstruct sidewalk panels from parking sign to facility entry way with compliant run and cross slopes. If topological issues make walkway run slope compliance infeasible, seek a MAAB Variance for the noncomplying run slopes and replace sidewalk panels from sign to edge of narrow entrance with least possible cross and run slopes.

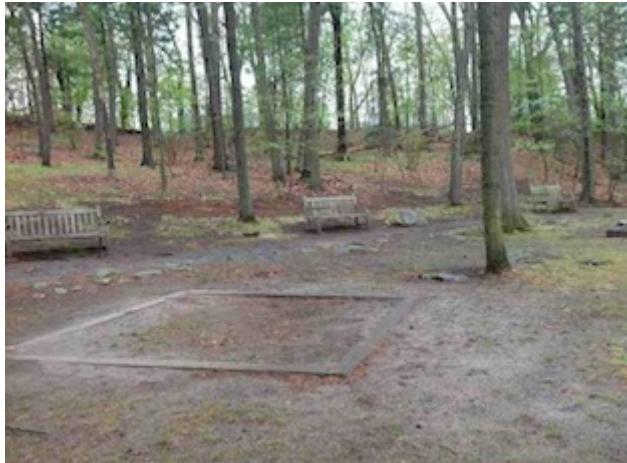
Photo 8

Their needs to be at least 1 accessible pathway connection from trail to the picnic area's 2 accessible tables; and in addition, a connection needs to be established between trail and the Woodhenge circle. (Photo 8)

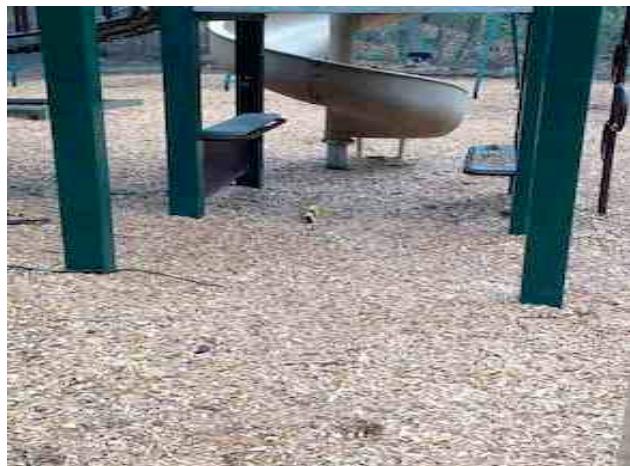
Photo 9

These surface materials may fulfill impact-attenuating requirements, but they are not accessible because ground surface materials show excessive cross slopes and depressions near and within accessible ground play elements. (Photo 9)

- a. If only loose fill ground surface materials are used, implement a high-frequency maintenance program to ensure accessibility of ground surface materials through all seasons.
- b. If ground surface materials will be replaced: consider adding unitary surface materials within the playground areas to provide accessible routes and clear ground spaces to all entry/exit points of ground play elements, including swingsets, play structure transfer station, and ground play elements.

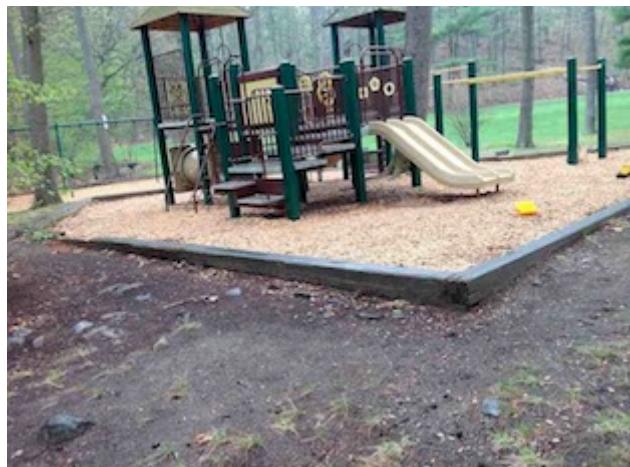
Photo 10

The playground border is a barrier to accessible entry into the play area because it has level changes of between 2 - 8 inches above the trail and there is currently no accessible entry point into the play area. (Photo 10)

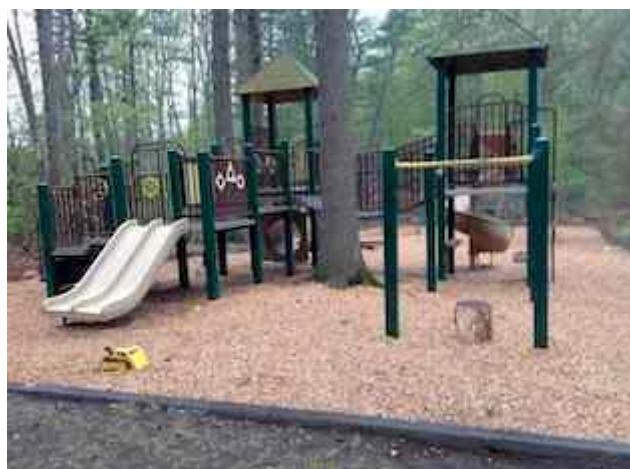
Photo 11

A transfer system provides stepped connection to at least 50% elevated elements, and there is no accessible (ramped) elevated route. (Photo 11)

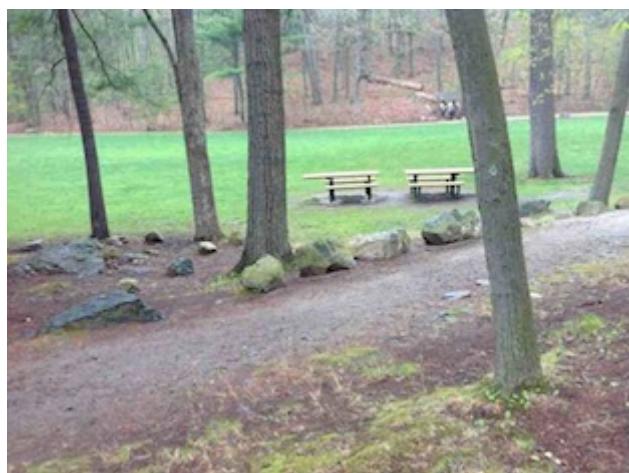
Photo 14

There are two accessible picnic tables provided. These thoughtful tables need to be connected to an accessible path branching off the main graded trail. (Photo 14)

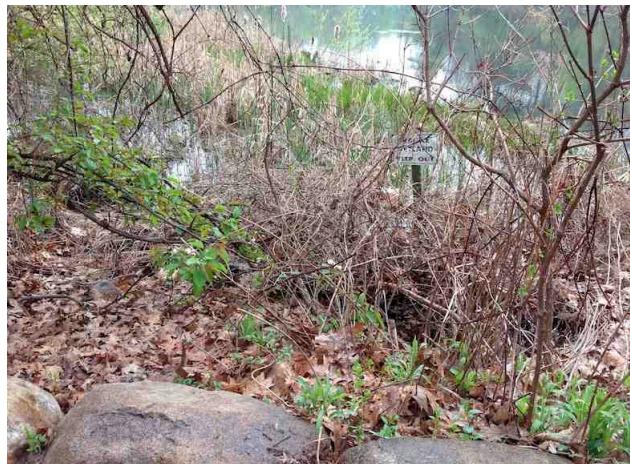
Photo 17

Cautionary signage in the wetlands section of the graded trail is mounted beyond the rocky border and obstructed by vines. Safety and information signage along trail should be inventoried and reposted where it may be beyond viewing distance or obstructed by natural growth. (Photo 17)

Best Practices Recommendations:
Inventory safety signage along trail and relocate where visibility may be obstructed.

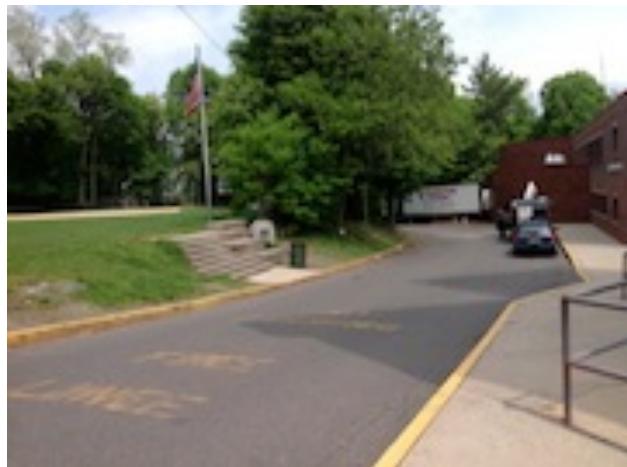
Photo 3

There is no sidewalk provided on the east side of Acton St. from Appleton Pl, and no sidewalk provided on facility side from the Benjamin Road pedestrian sidewalks into the parking lot.²⁷ (Photo 3)

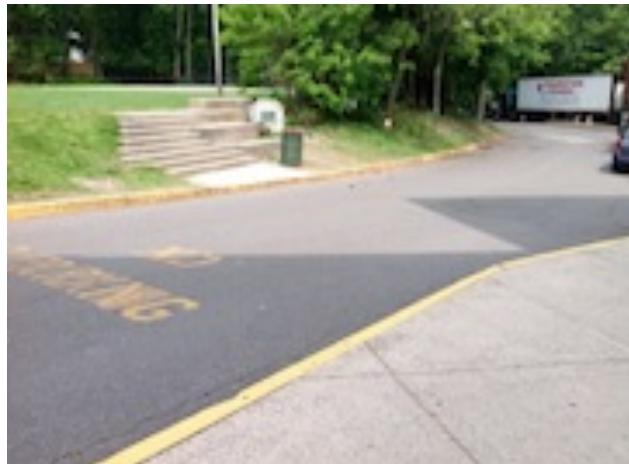
Photo 7

The stairway opposite the school entrance is not adjoining an access route or any sidewalk; and is in disrepair. There is no matching accessible ramp provided. (Photo 7)

2, Repair staircase and add accessible handrails and a level top landing.

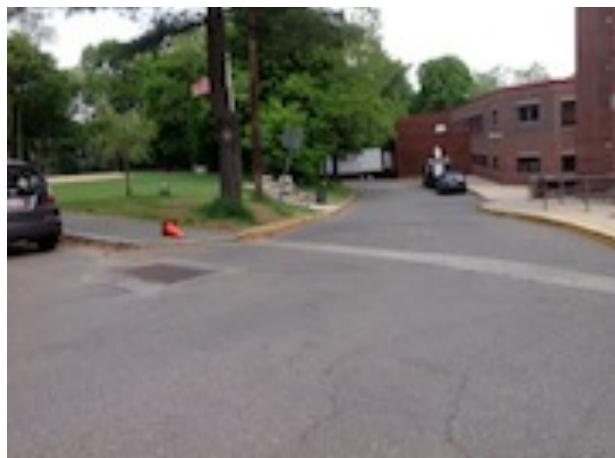
Photo 8

The entry to field from accessible parking spaces includes a curb at the corner followed by a paved path with excessive cross and run slopes. (Photo 8)

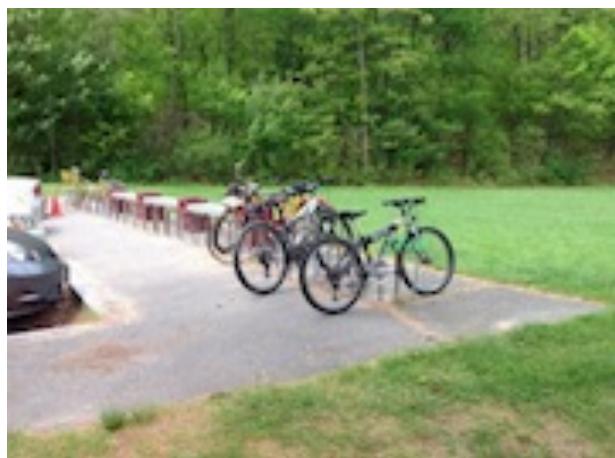
Photo 9

This walkway has an uneven surface, excessive cross and run slopes, and has a bike rack located at the side that is closest to the accessible parking spaces, obstructing the general public's path of travel onto the field from the parking lot. (Photo 9)

This walkway does not connect to at least one accessible interior walkway that provides a firm, level, smooth (non-grassy) continuous route connecting to the perimeter of the field playing areas, the dugout areas, team seating locations, the portable toilet, and the spectator seating along the fence.

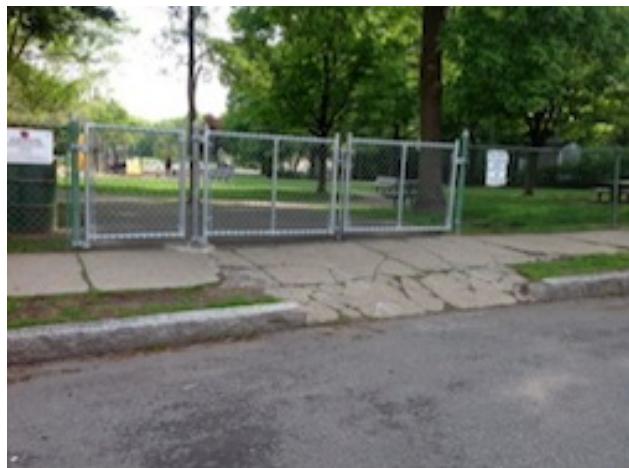
Photo 4

Entrance has 2 fences. Sidewalk apron is cracked and uneven and sidewalk pavement has excessive cross slopes. The entrance needs maintenance. (Photo 4)

Repair cracked sidewalk panels at entry gate.

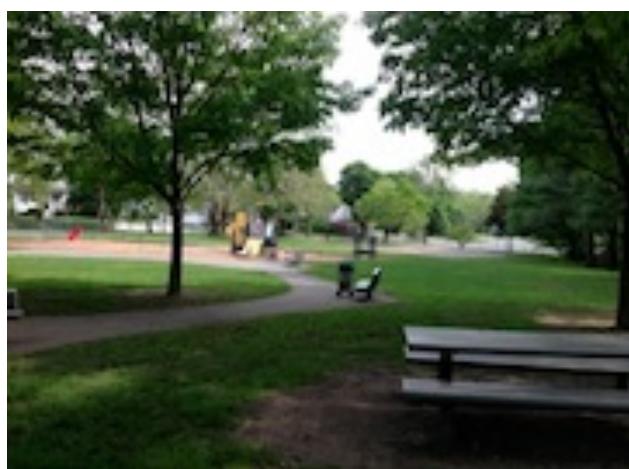
Photo 6

Walkways circulate through the park and around the play areas. The walkways are well graded, smooth and have compliant widths. However, they do not provide a route to all the park features, such as an accessible approach and entry into the play areas, to either side of the court, and to the benches and picnic tables. (Photo 6)

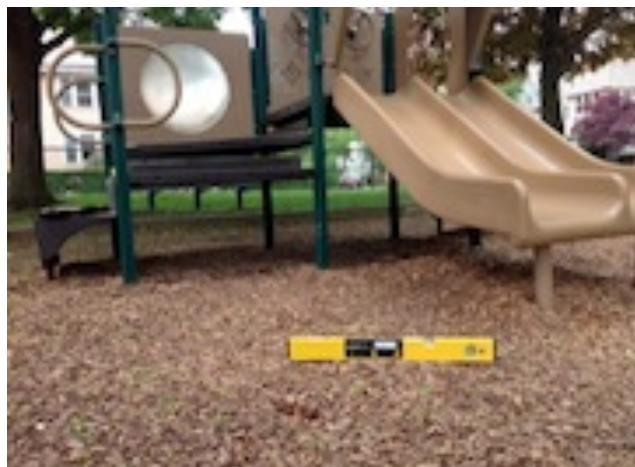
Photo 8

The loose fill ground surface that covers the play areas will require frequent maintenance to ensure an accessible route to all entry/exit points of accessible play components.

At this time, the loose fill materials are showing excessive cross slopes and holes. These uneven conditions prevent smooth, accessible and unrestricted circulation around the play structures. (Photo 8)

a. If only loose fill ground surface materials are used, a high-frequency maintenance policy needs to be in place to ensure accessibility of ground surface materials in play area use zones through all seasons.

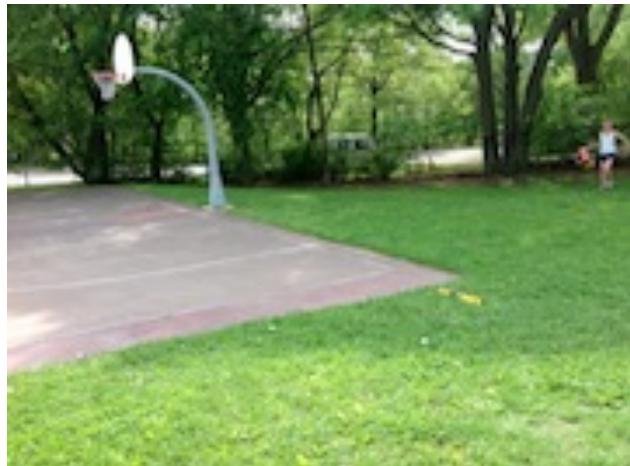
Photo 10

A basketball court is not connected by accessible route to the other areas and elements of the facility, including the entrance. (Photo 10)

Slope measurements taken to one side of the court indicate that it may be feasible to add a graded walkway connecting at least one side of the court to the play area, circulation routes, benches and tables, and entrance gate.

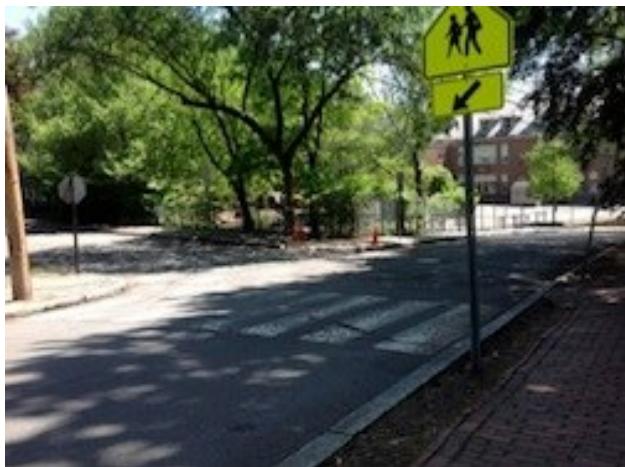
Photo 2

Crosswalk at Irving and Academy St. is highly inaccessible with steep slopes. The Pedestrian Safe Crossing sign is mounted on an unsafe, not smooth completely inaccessible brick sidewalk. There is no curb ramp at either end of the crosswalk. On the school side, the curb cut is unusable, with no flared sides, no accessible slopes, and no bottom landing. (Photo 2)

When street reconstruction is planned for Irving St., replace brick sidewalk on SW side with smooth surface panels, such as concrete or asphalt, which, if constructed correctly, can be maintained as accessible for the life of the build.

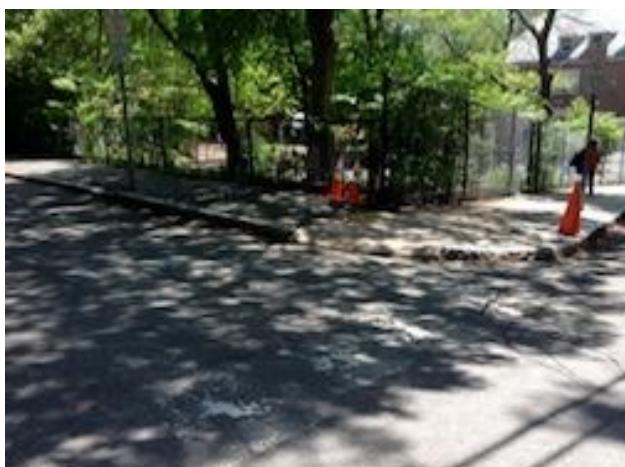
Photo 3

Curb ramps at Academy St. and Irving are either missing, in disrepair, or, where provided, are incorrectly constructed with steep slopes and lack of bottom and top landings. (Photo 3)

These issues negatively impact the provision of an accessible route connecting facility to site arrival points, including the nearby public transit stop at Pleasant @ Irving St. and the adjacent streets and sidewalks.

Reconstruct sidewalks and curb ramps from Public transit stop to intersection of Pleasant & Irving St. At curb ramp nearest APS pole, replace apex curb ramp with blended curb ramp oriented towards east.

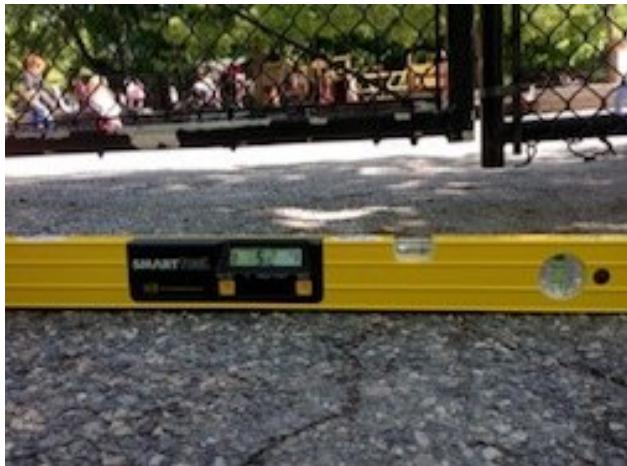
Photo 4

Sidewalks from Pleasant St. & Irving to facility have excessive cross slopes. and require repair around the perimeter of facility. (Photo 4)

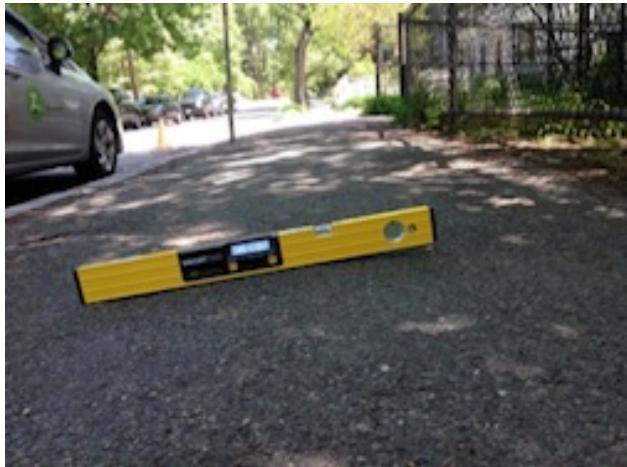
Photo 5

Sidewalks along Academy Street do not have topological constraints and need to be mitigated to provide accessible walkway slopes. The cross slopes near the Academy St. gate exceed 8% in places, where the maximum should not be more than 2.08%. (Photo 5)

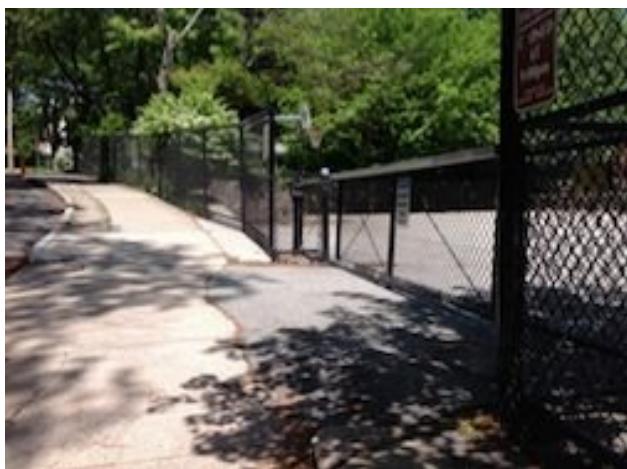
Photo 6

Both points of entry have excessive cross slopes. The sidewalk and entry panels near the gate are in disrepair. (Photo 6)

1. Replace driveway apron at Irving St. entrance with sidewalk that blends to 5% at entrance within pedestrian zone. Repair cracks in asphalt and ensure that ground materials match levels. (about 4 S.F.)
2. Reconstruct recessed entryway from curb to gate at Academy St. entrance. (about 6 S.F.)

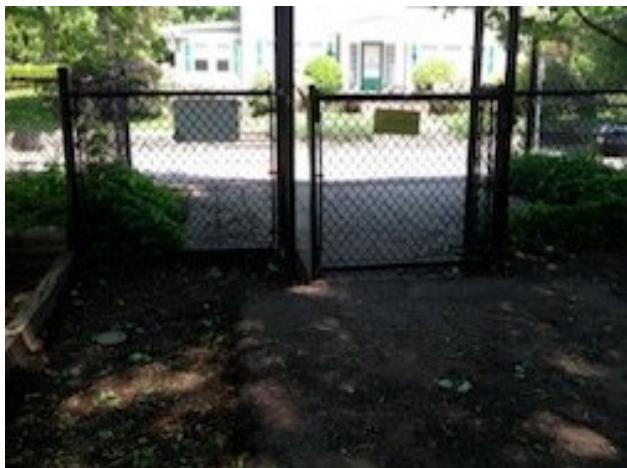
Photo 7

The gate at Academy St. leads from a sidewalk with excessive cross slopes and the ground surface is uneven. (Photo 7)

Both gates require smooth surface hardware on the push side.
